Building Inspection Report

Address of Building Inspected:

**152 Highland Avenue
Torrington, CT 06790**

Inspection Date: **05-05-08**

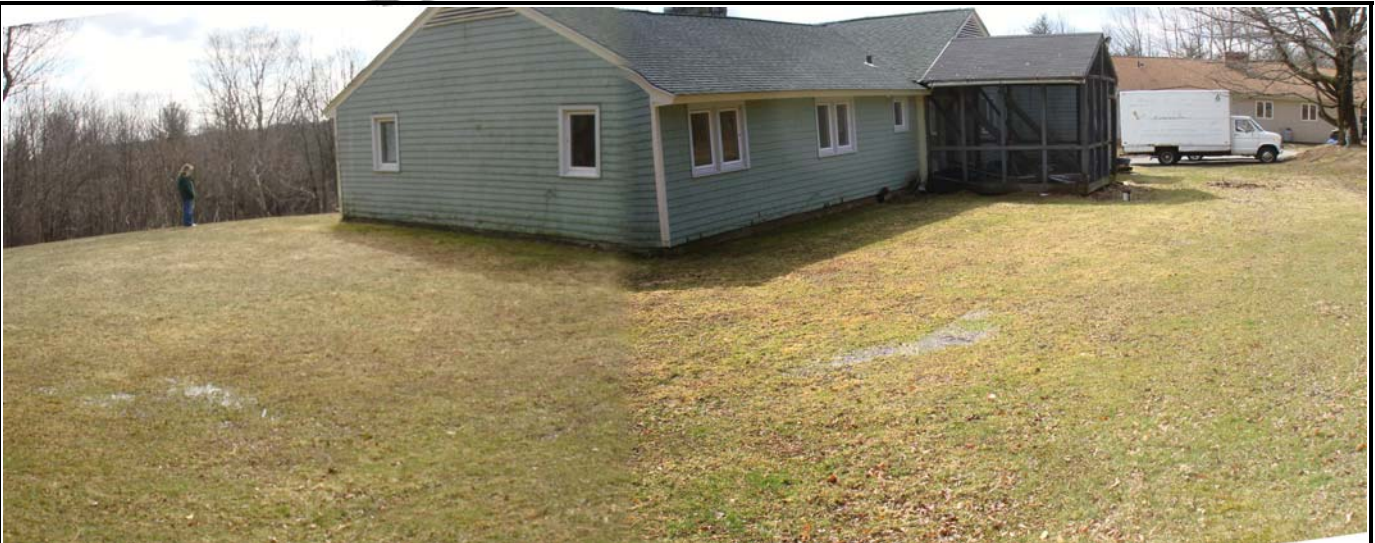
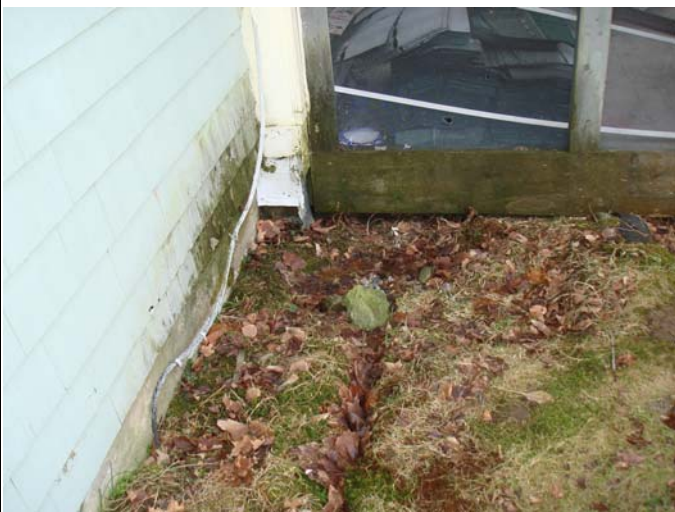
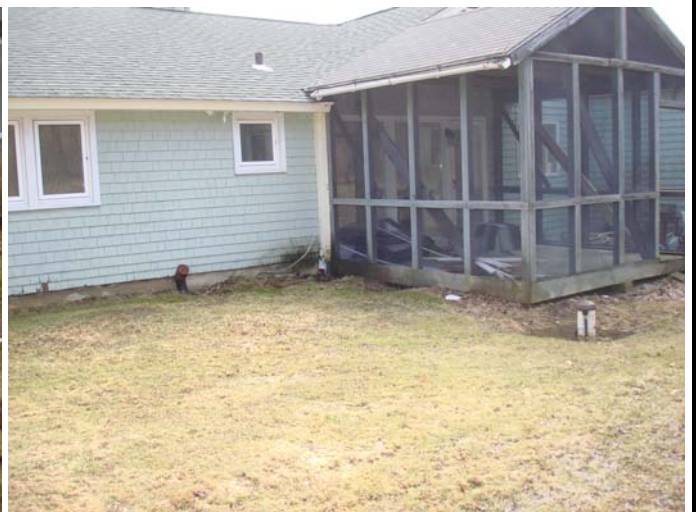
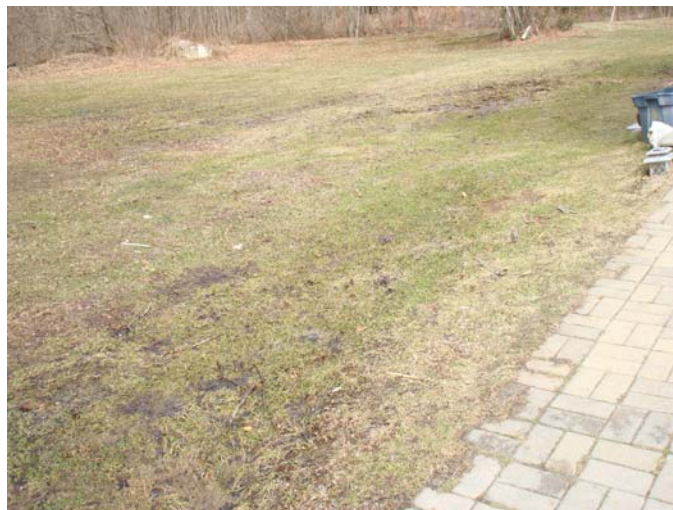
1. **Ground elevation is toward the building at the rear of the property. Standing water on the ground was present at the rear of the building. Low areas are present along the foundation on the rear & under the rear screened-in porch. Grading is higher on ends of the building causing water to be trapped behind the building. There is sufficient grading to create swales on each end of the building to drain water to the front of the property. This will reduce basement moisture & any water entry.**

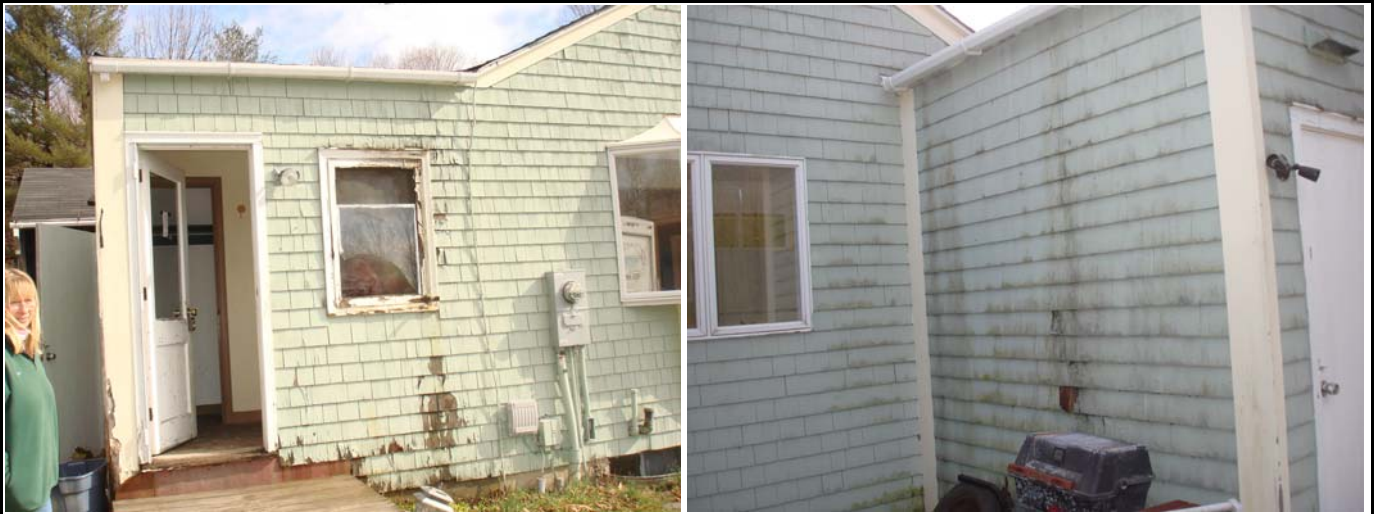
1. Siding is deteriorated on both sides of the rear entry room. This deterioration appears to be caused by poor roof drainage. Roof drainage should be corrected when this roof is replaced.

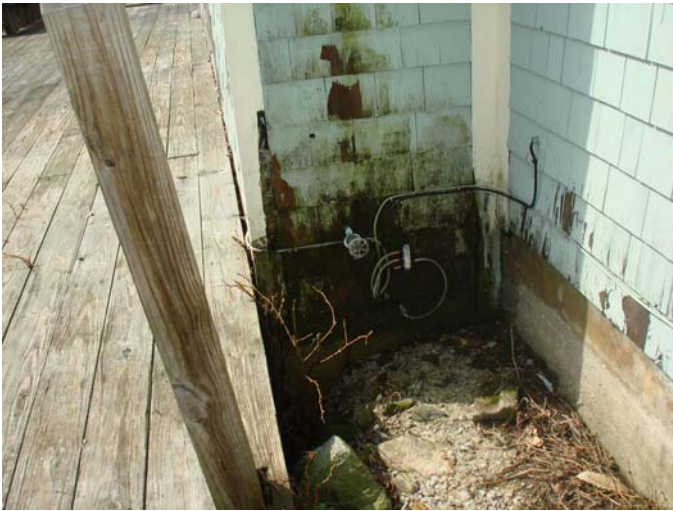
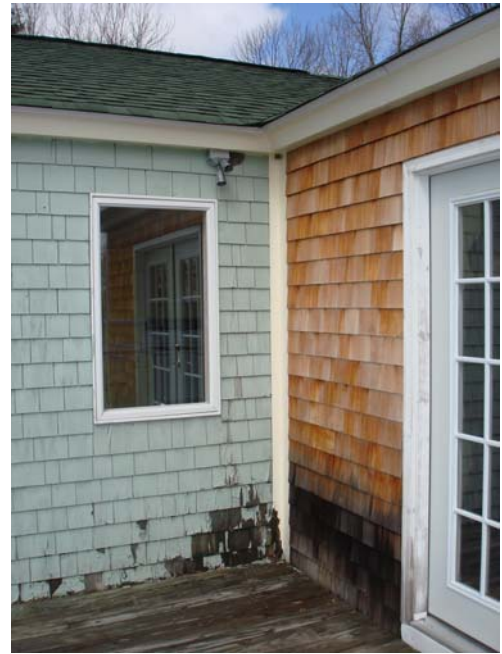
2. Siding is soft & deteriorated from water exposure on the left & right sides of the deck. It should be replaced. Gutters should be installed on the building.

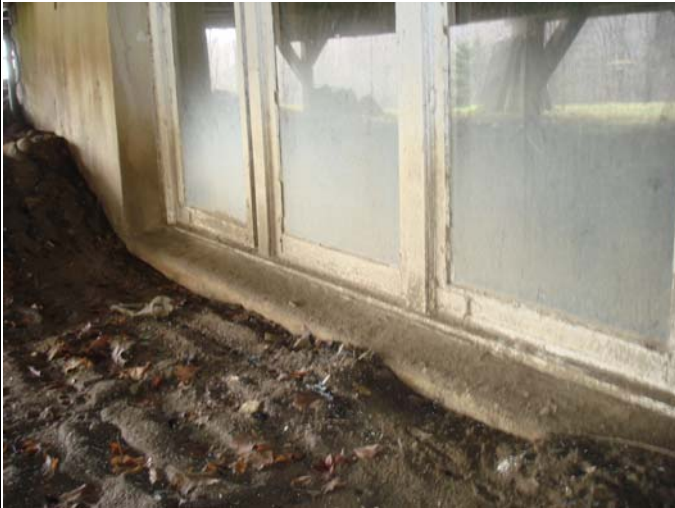
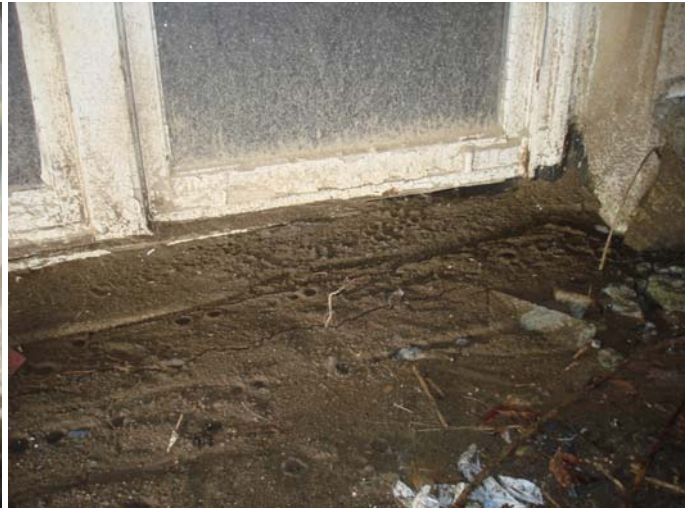
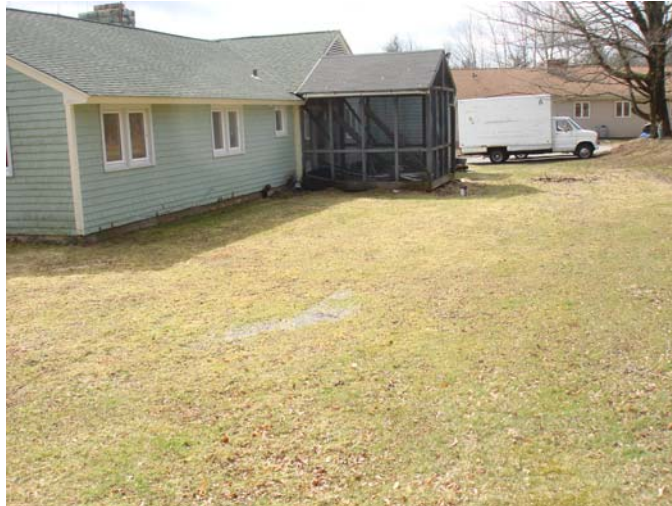
1. Gutters are not installed on the building. Water drains directly against the foundation & onto the front deck. Water drains directly against the foundation at the rear. Siding is decayed at the front deck where water from the deck splashes against it. Water drains off the front of the building &

under the deck. Soil is washed under the deck & over basement window frames. Some frames are decayed. Install gutters on the building. *

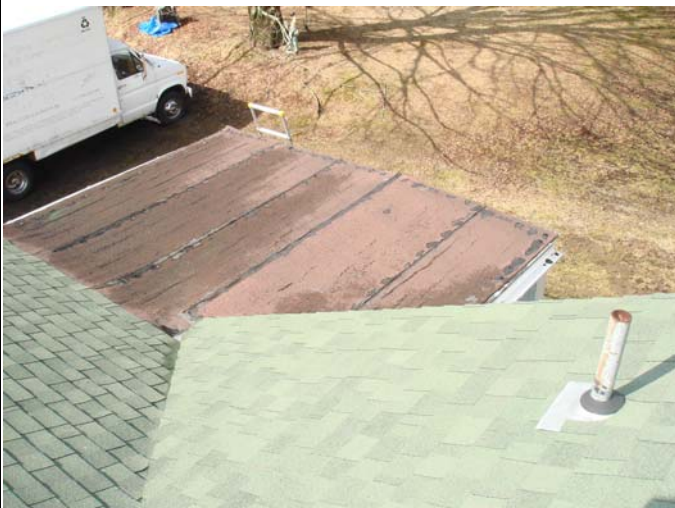
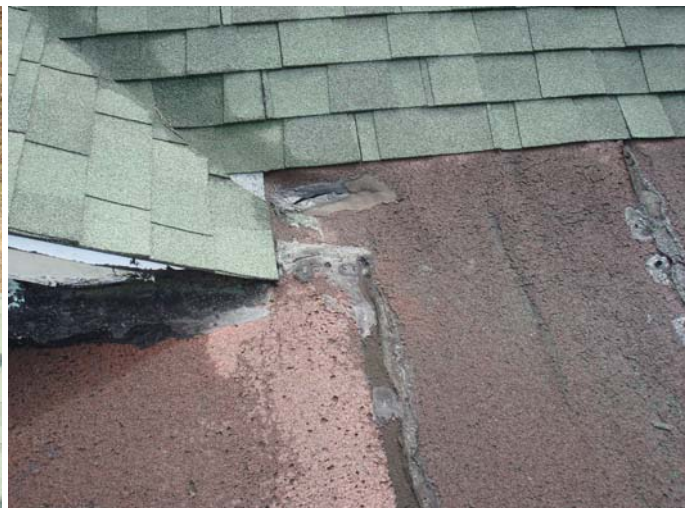
2. **The flat roof on the rear portion of the building needs replacement. Visible holes to the interior are present. ***

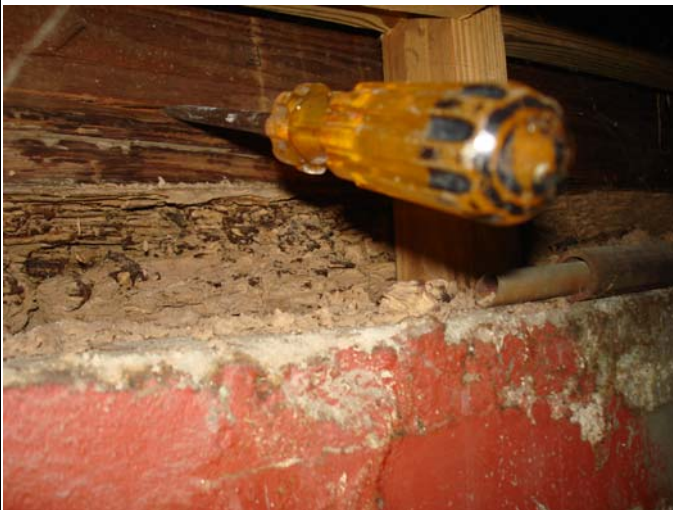
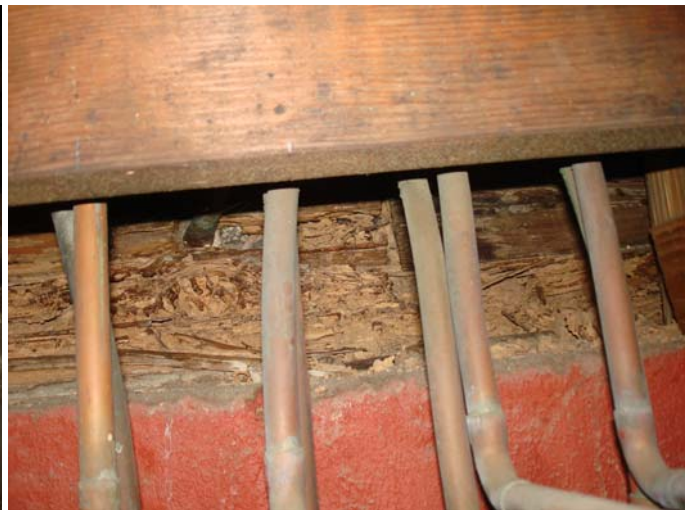
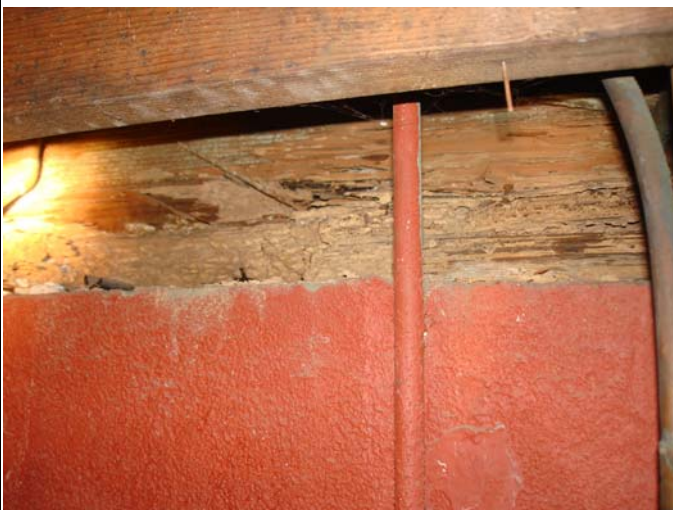
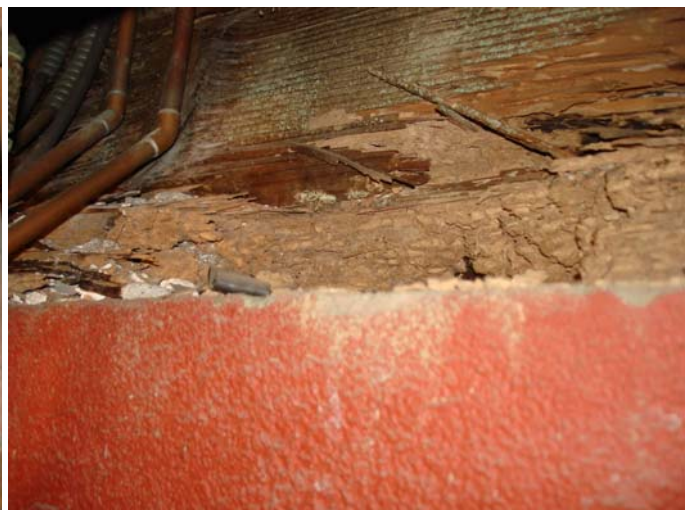
3. **Extensive termite damage is present on the entire length of the main sill beam along the right basement wall. This damage extends to the exterior of the building at the front behind siding at the corner of the basement/slab portions of the building. Damage is also present to sub-flooring in the center portion of the building. Damage extends to building framing in the slab (right) portion of the building & baseboards in both bathrooms & closets near bathrooms. Damage was also observed in 1 area in the attic. Newly installed laminated floors & baseboards may conceal damage in other areas of the right portion of the building. This damage is extensive & costly to repair. Expect expenses of \$30,000+ if contractors are hired to make repairs. ***

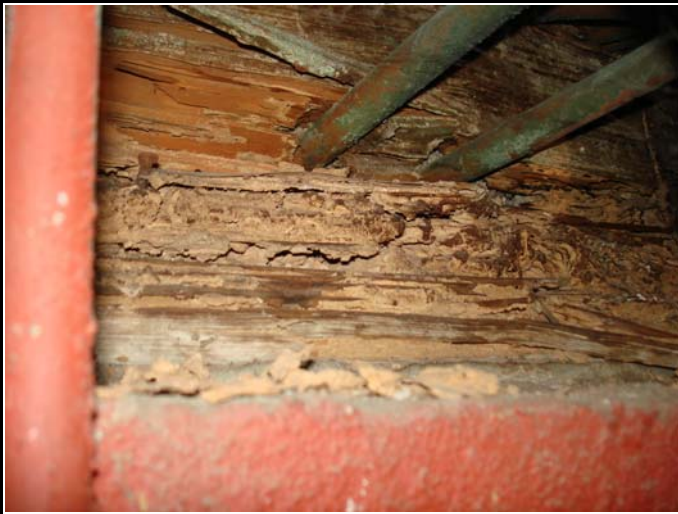
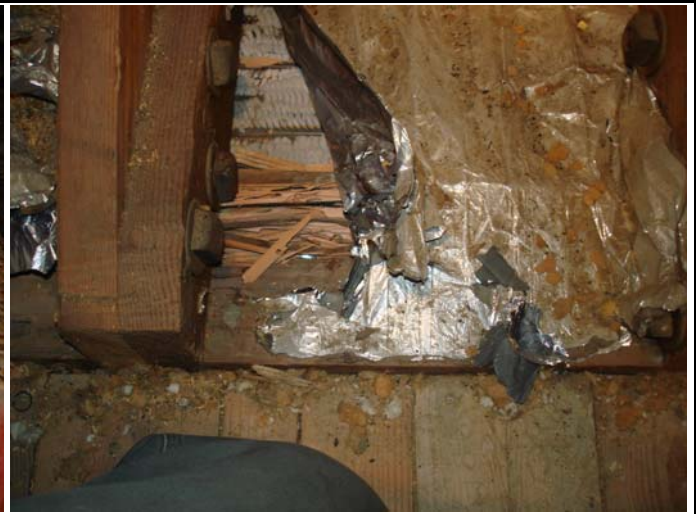
Damage to sill beam in basement.

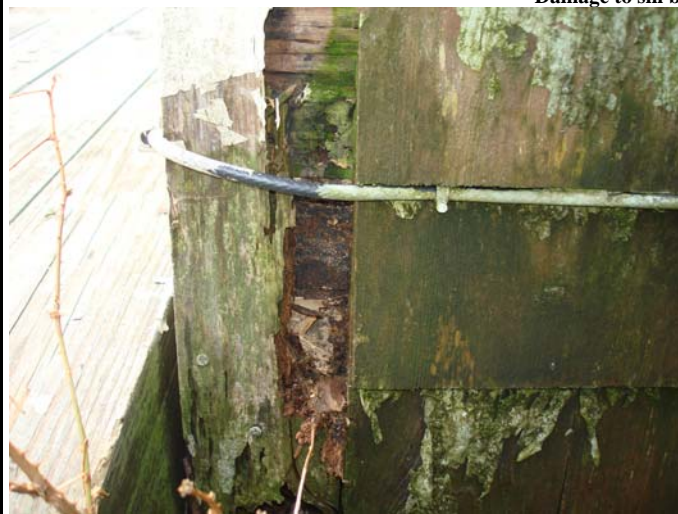
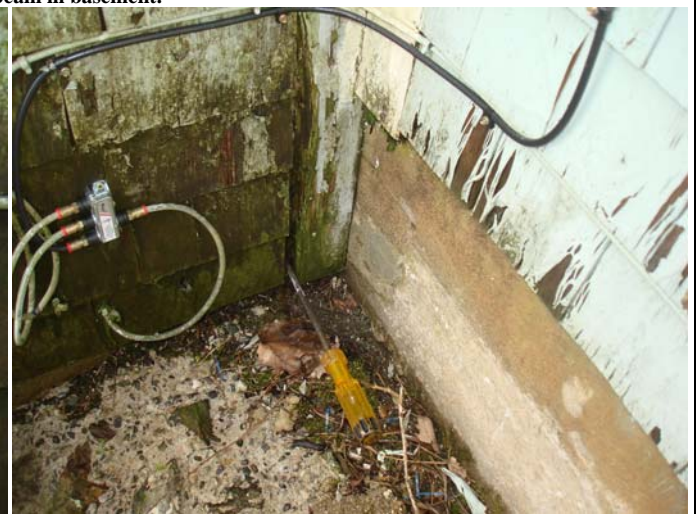
Termite damage & decay of the sill beam on the exterior.

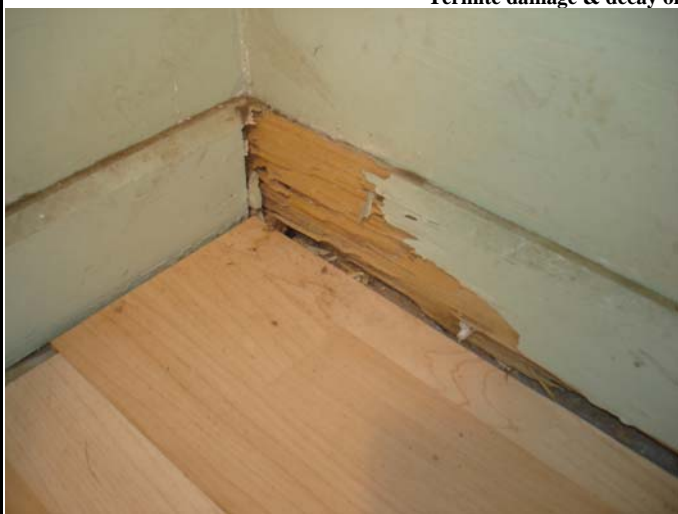
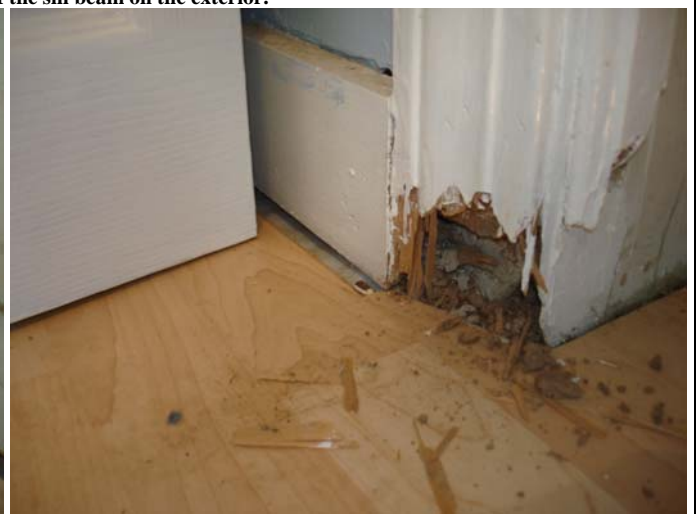
Damage near front bathroom.

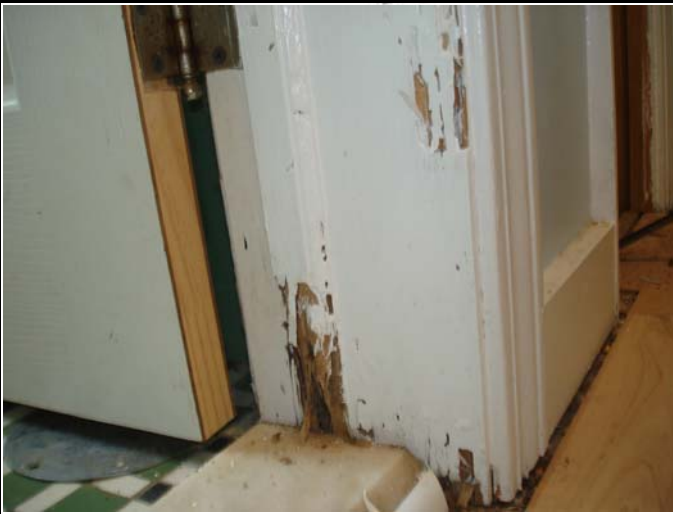
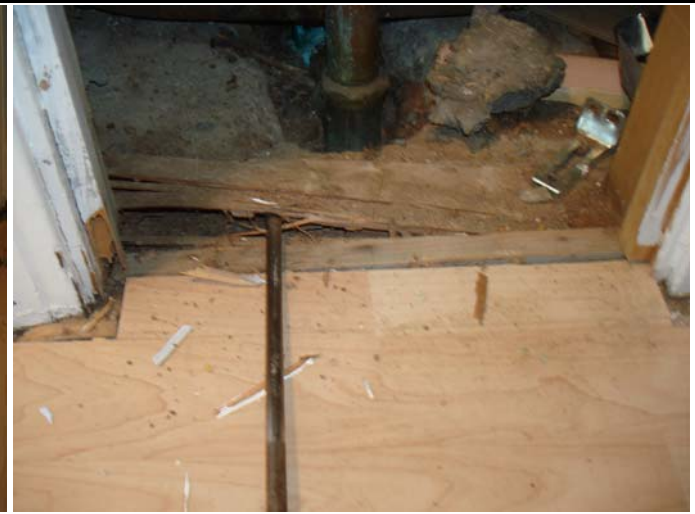
Damage near front bathroom.

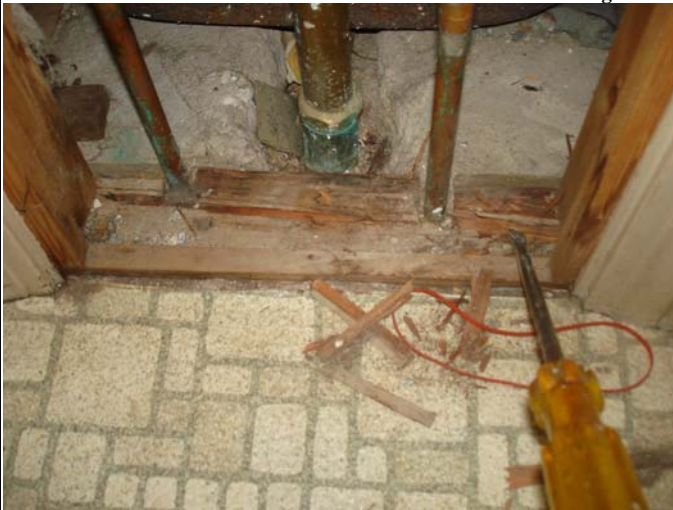
Damage at rear bathroom.

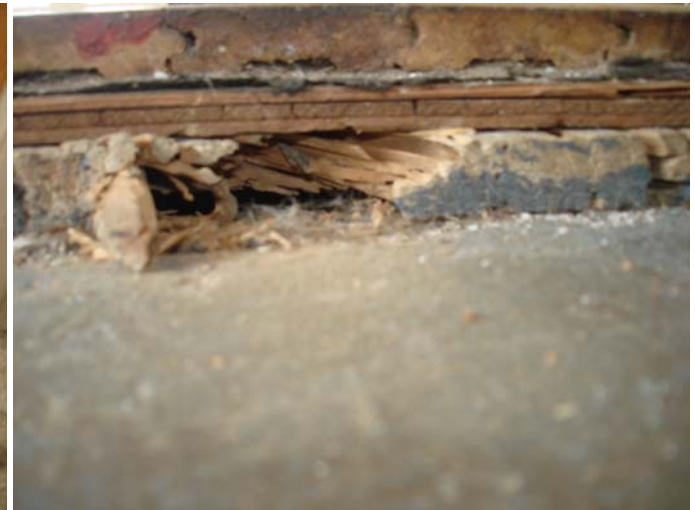
Damage at edge of living room floor.

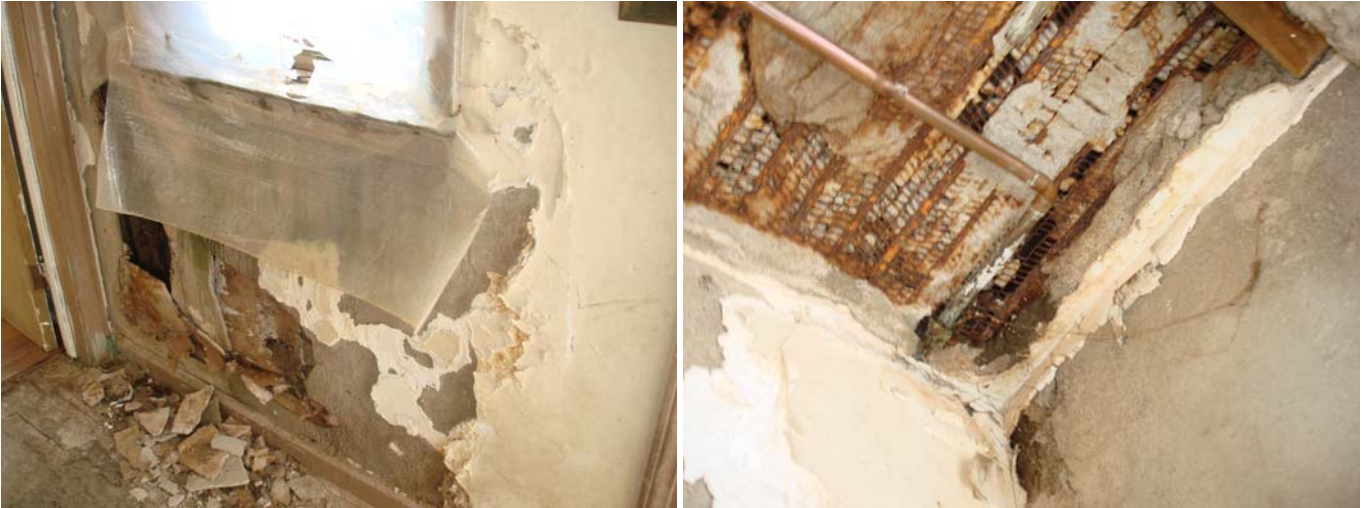
2. **Walls & the ceiling are completely deteriorated at the left-rear entry. It appears this damage was caused largely by roof leaks. Plaster was wet in the area of a heating pipe in the ceiling. The possibility exists that a small leak may be present in this heating pipe. Investigate further.**

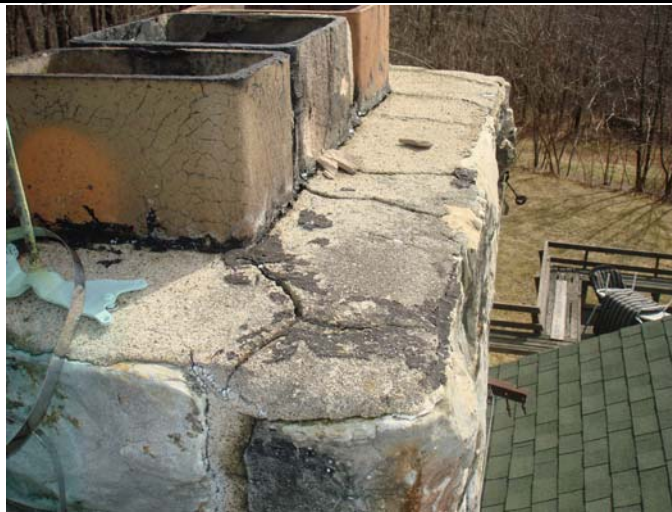
1. A rain cap is not installed on the chimney. Water enters the chimney structure & flues & deteriorates chimney mortar & the flue liner. Debris can also enter the chimney & plug the base. *
2. **The top chimney wash is deteriorated. It should be replaced to prevent water entry into the chimney structure. ***

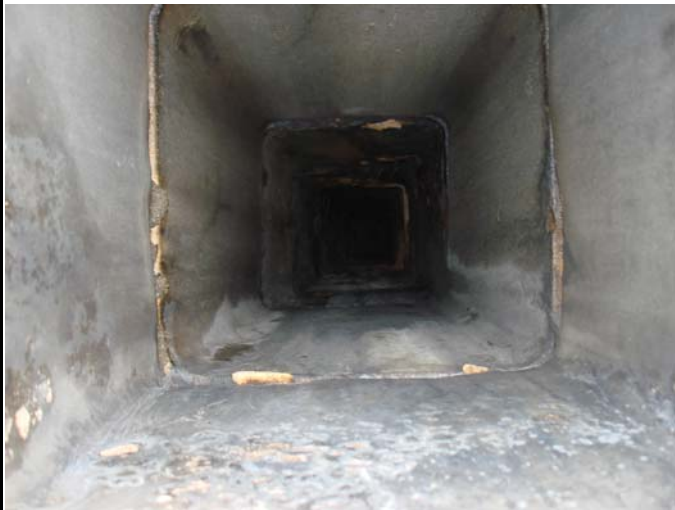
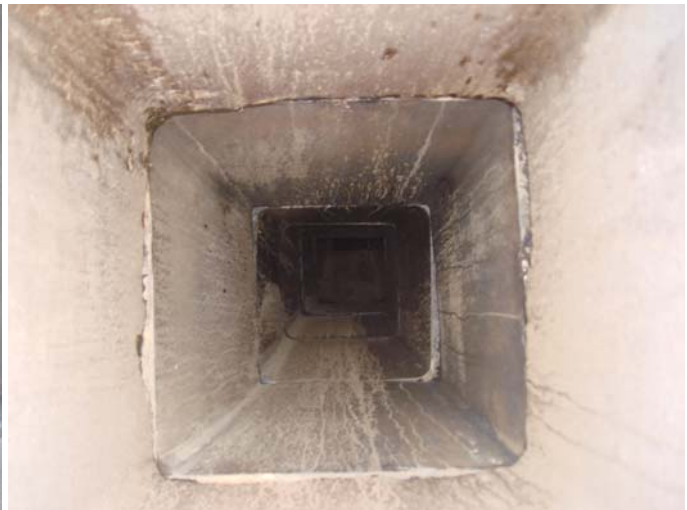
Condition of fireplace flues.

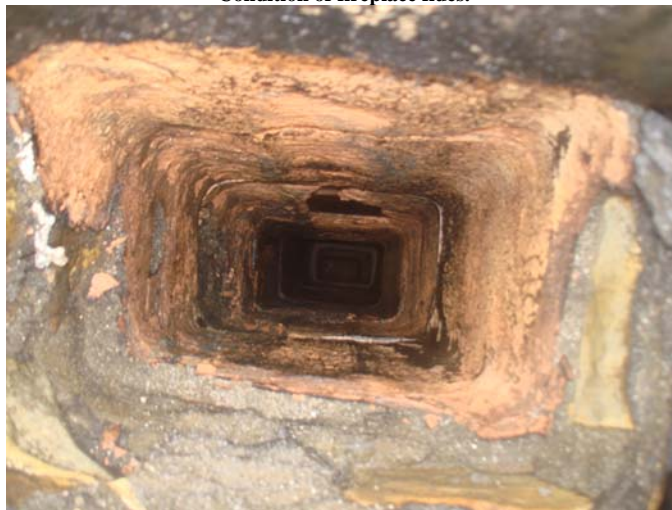
3. The flue liner for the boiler is deteriorated. At some point in time it should be replaced.

Condition of boiler flue.

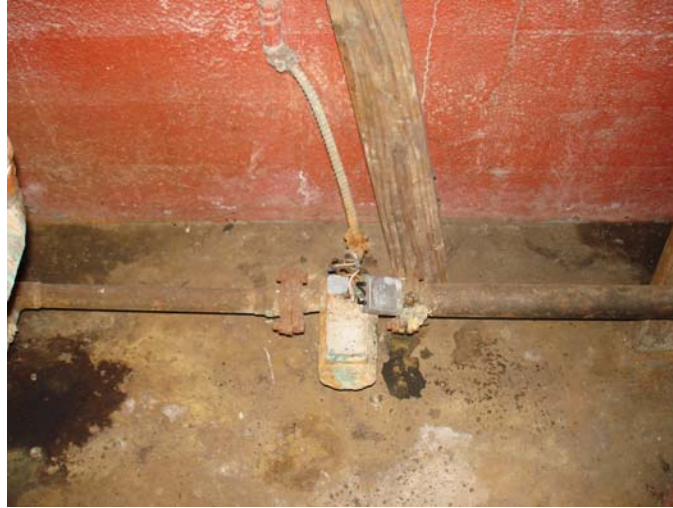
1. **The heating boiler has been unmaintained in the recent past. It should be completely serviced. This includes removing the top cover & cleaning the flues. ***
2. **The junction box on the circulating pump for one of the heating zones is damaged. "Live" electrical wires are exposed. The junction box needs replacement. ***

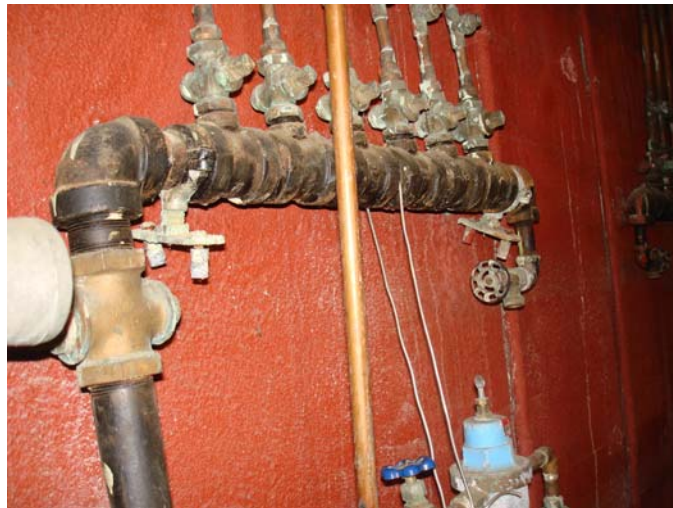
3. This building has radiant heat installed for heat distribution. Typically, this type of heat is not set back to reduce energy consumption. Radiant heat takes a longer period of time to heat a building. There are more modern controls available for this type of heat that may reduce energy consumption & heat the building more uniformly.
4. Heating pipes for one of the heating zones are unsupported on the basement wall. Previously installed wall anchors have pulled from place.

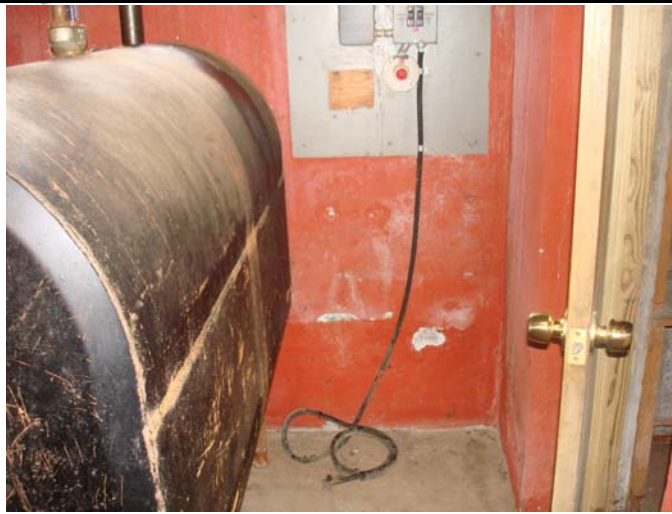
1. **This building has electrical panels & a changeover switch to use a generator for emergency power. The cord to connect the generator to the electrical system is unterminated & lying on the basement floor. If the circuit breakers for this system are turned "on", this wire would have electric power. This is a shock hazard. ***
