Building Inspection Report

**28 Adams Street
Goshen, CT 06756**

Inspection Date: **03-23-17**

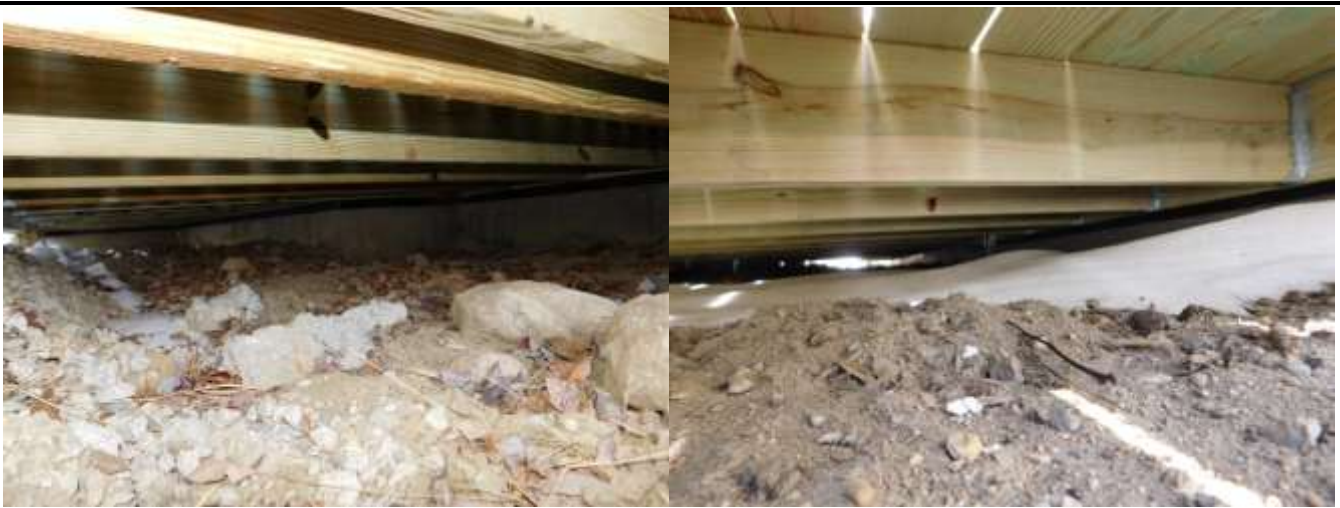
- 1. The foundation has been insufficiently backfilled under the front porch and rear deck. Roof drainage will puddle against the foundation.**

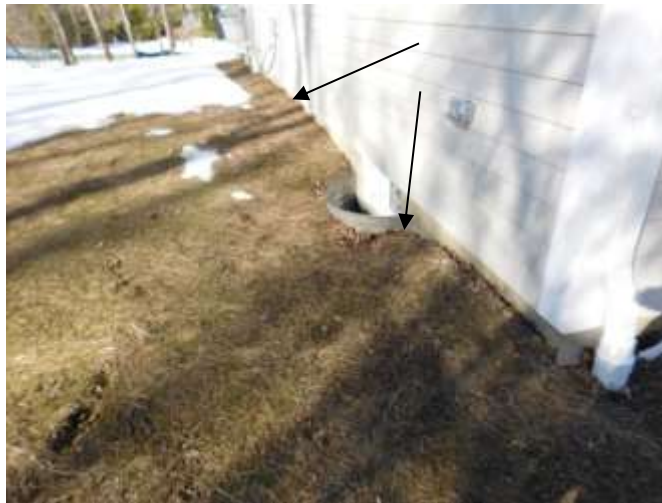
- 2. Window wells on the right side are installed too low. Insufficient soil is installed along the foundation. Wells need to be raised and additional top soil added.**

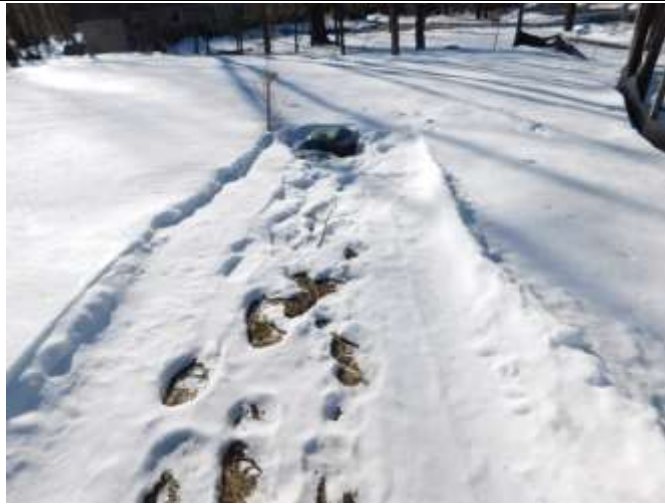
- 3. Ground elevation is low around the propane tank access cover. Soil elevation should not extend near the cover to allow soil to erode into the tank access opening. Correct grading.**

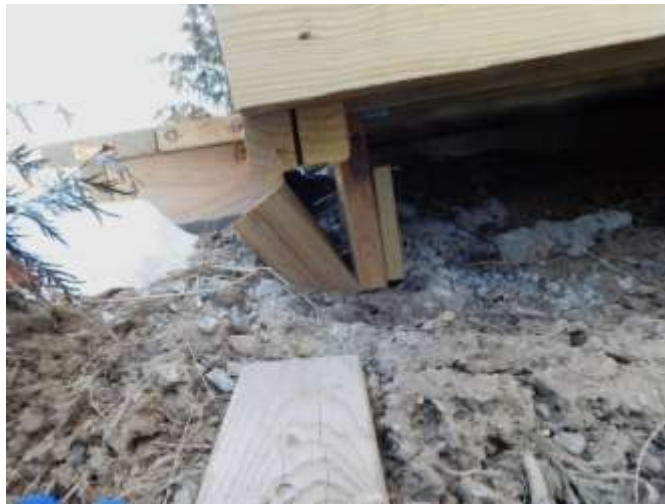
1. **The left-front support for the front entry porch has failed. It is pieced from smaller pieces of lumber. The porch should be supported with a solid post installed under beams for the porch support structure. This is poor construction.**

- Have Licensed Pest Control Company Inspect
- Treat For Infestation
- Have Carpenter Assess Damage & Repair

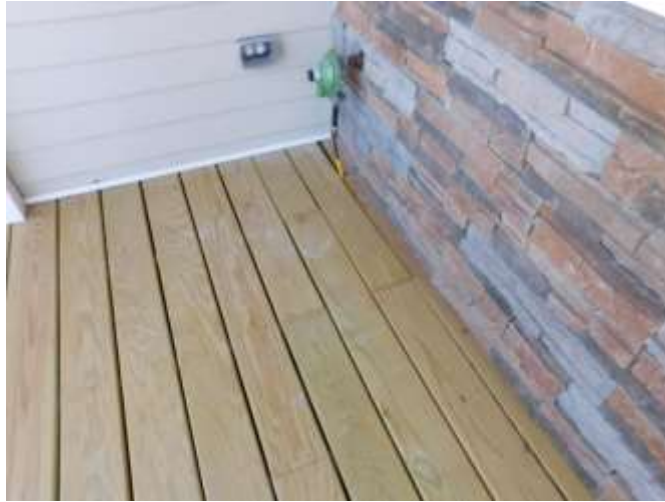
2. Window screens are not installed. Screens are present in the building but an inventory was not taken.
3. A sliding screen door for the rear deck entry was not present.
4. Front pooch deck boards in the left corner are not attached to porch framing. These boards may have to be removed to access the propane entry connection into the building. Stainless steel screws are the best method of attachment that will allow future removal.

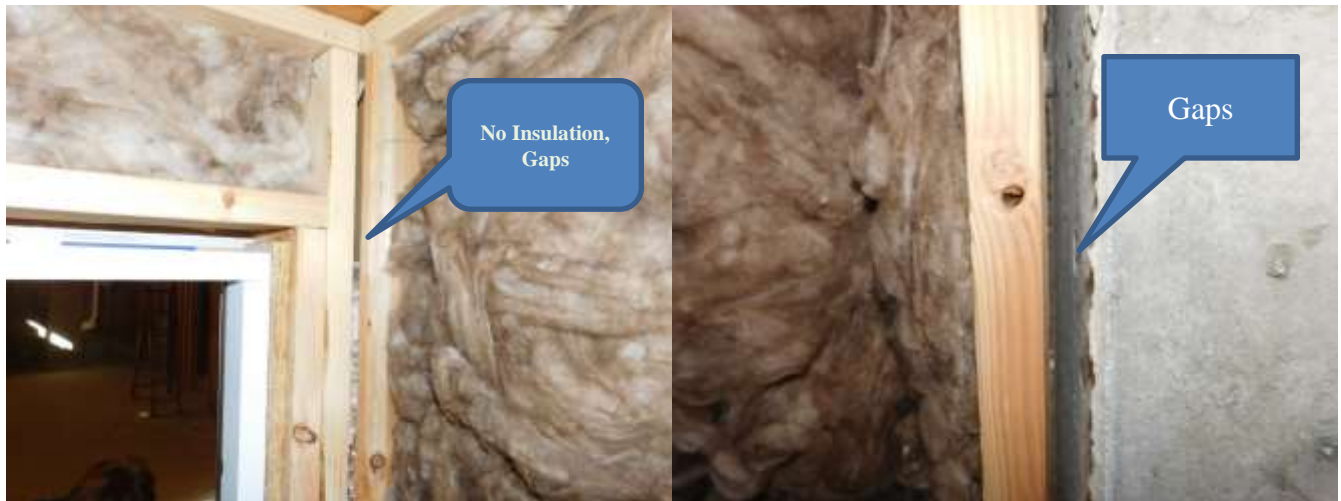
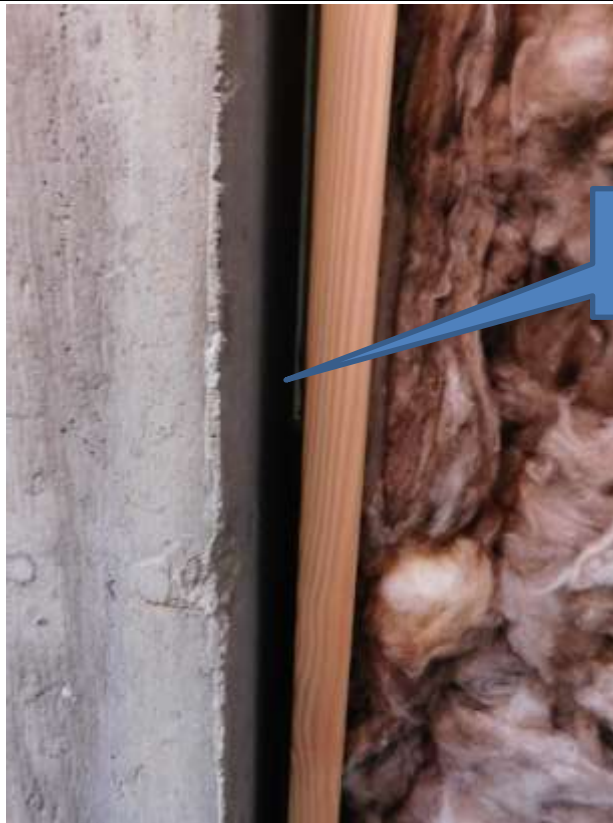
1. **The metal basement hatchway entry door framing on the inside have gaps that allow cold air infiltration into the basement. This structure is poorly sealed and insulated. Eliminating cold air infiltration in all areas maintains the inside temperature of the building in winter weather.**

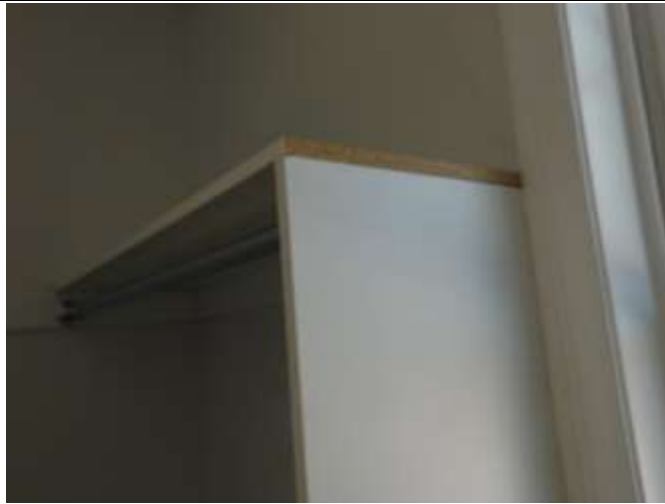
1. The interior of the building is in good condition.
2. Rough sawn wedges are visible on ends of shelves in the closet in the right-front corner of the 1st floor.

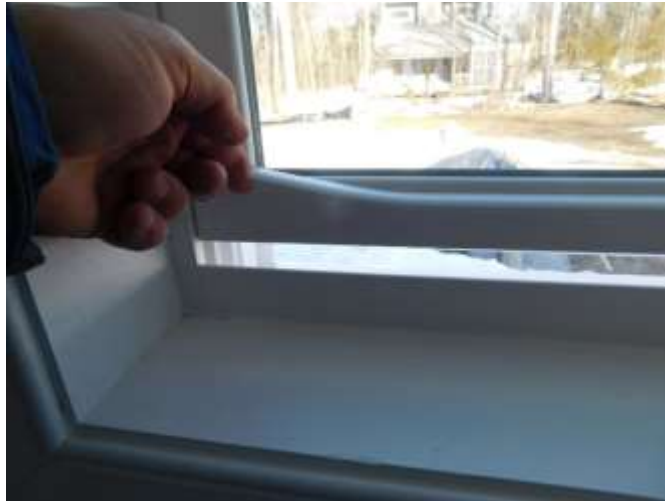
3. The handle is broken on the left side of the window above the laundry sink.

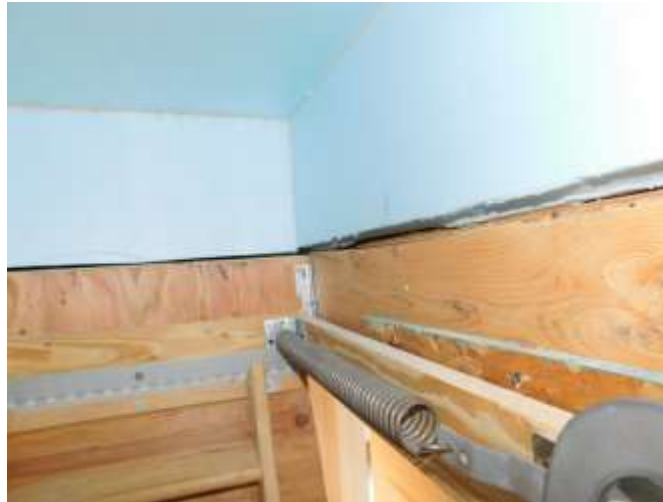
1. Heat loss occurs through the pull-down attic stairs in winter weather. The cover installed does not seal tightly against the floor and allows heat loss from the building. A gasket can be installed on the door. Proper fitting covers can be purchased: <http://insulattic.com/>
<http://www.attictent.com/>
